Rainwater Harvesting Pilot Project

This study and report were undertaken under the auspices of the National Rural Water Monitoring Committee by a project team from the School of Civil and Structural Engineering at Dublin Institute of Technology. The project team was led by Dr Seán Ó hÓgáin and Liam McCartan and included Anna Reid, Niamh McIntyre and Jenny Pender.

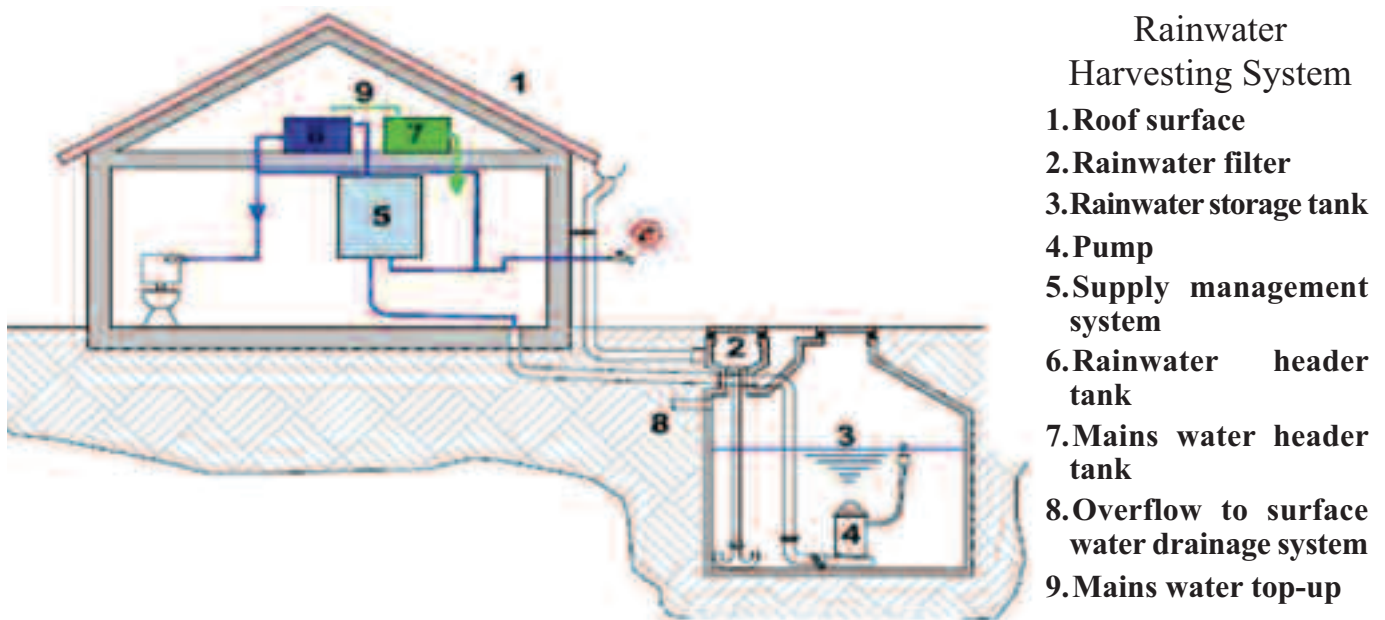
Fig. 2.1 Schematic of rainwater harvesting system installed in Carlow.

Figure 2.1 shows the components of the RWH system installed. The house roof is the catchment area (1), rain is collected by the gutters and flows through the downpipes through a filter and calming inlet (2) to the underground collection tank (3). A submersible pump (4) controlled by the supply management system (5) pumps rainwater on demand to the rainwater header tank (6) for supply to the household toilets and garden tap. A mains header tank (7) supplies all other water requirements as per normal plumbing practice.

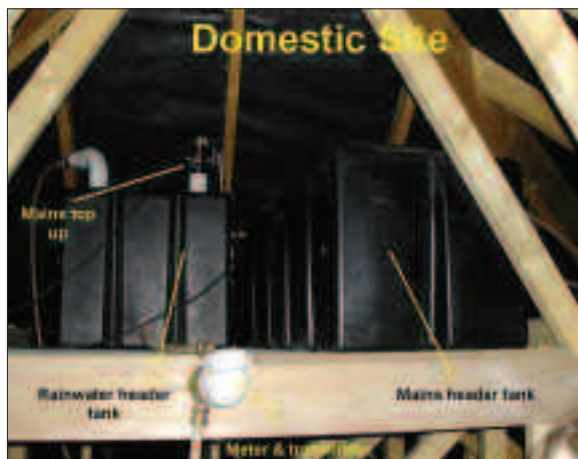
Fig. 2.2 Showing mains top-up to rainwater tank in attic.

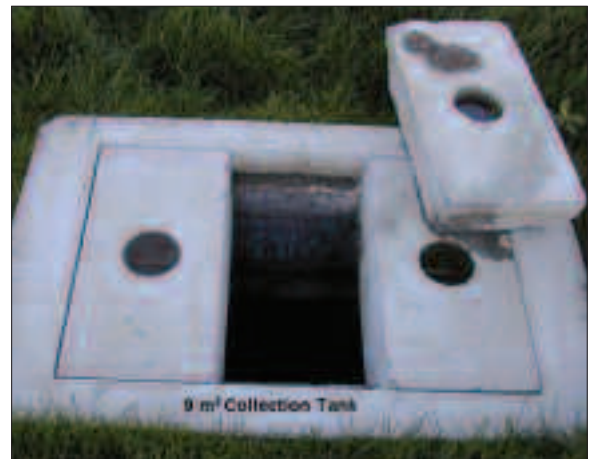
Fig. 2.3 Underground rainwater harvesting 9m³ storage tank.

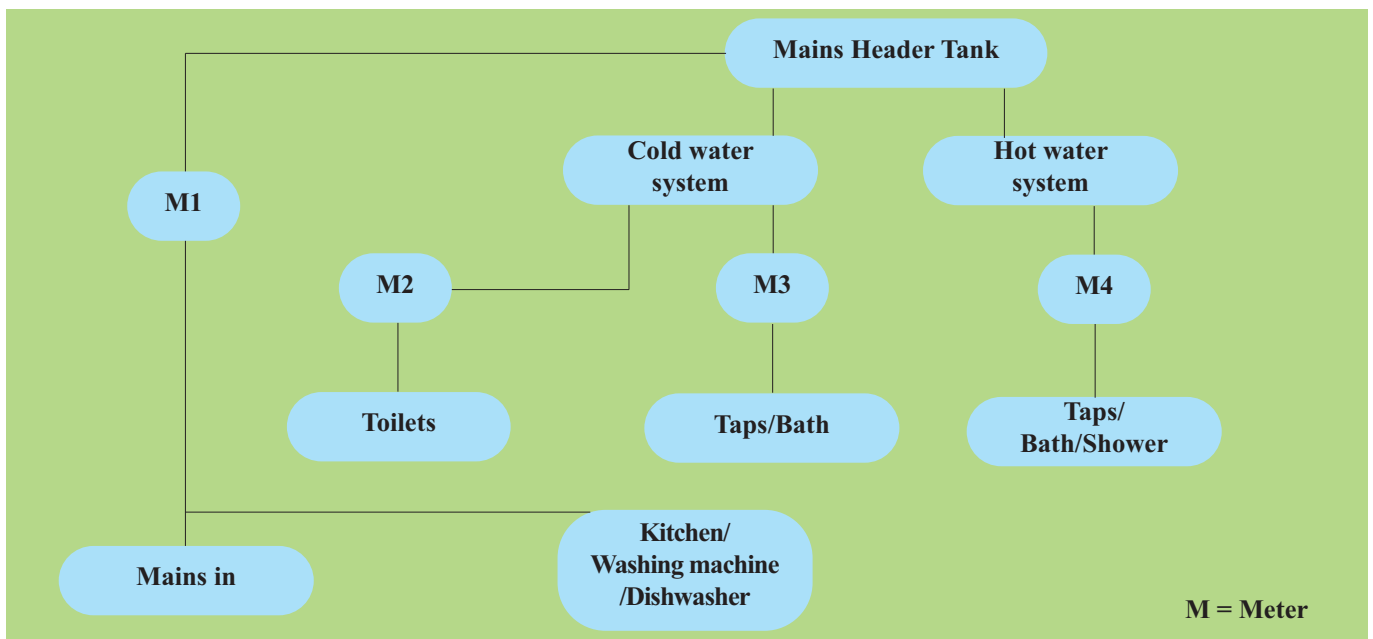
Fig. 2.9 Metering installations.

A metering plan as shown in Figure 2.9 was designed for monitoring water use within the control houses (mains water supply only). The meters used were Bonyto Klasse C 1.5m³/h type. Meter 1 (M1) monitored the mains demand within the household, M2 recorded water used in toilet flushing, M3 and M4 measured cold and hot water use respectively in the household at sinks and bath taps and any appliances such as washing machines and dish washers.

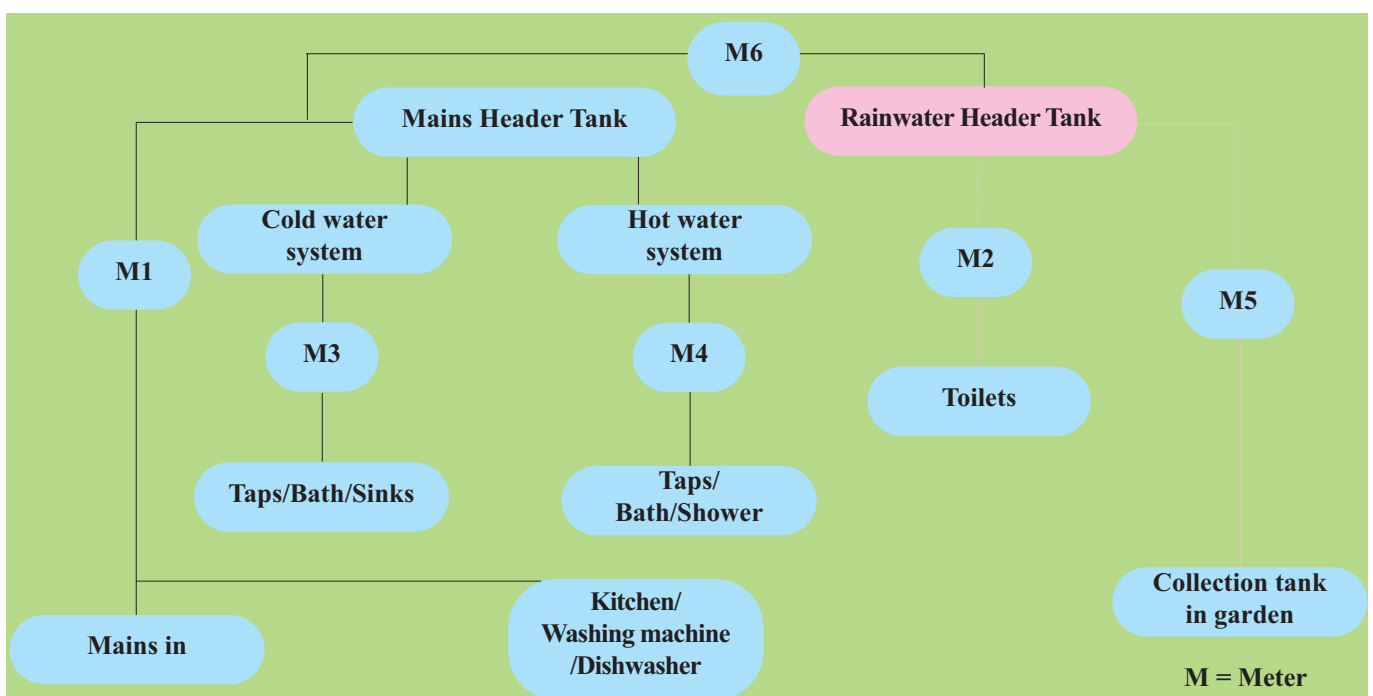
Fig.2.10 Metering schematic for initial rainwater harvesting house.

The metering system installed in all four houses in Phase 1 consisted of four meters (Bonyto Klasse C 1.5m³/h type). M1 was placed under the kitchen sink on the mains pipe to the house. This measured total mains water use. Meters M2, M3 and M4 were located in the hot press (airing cupboard), measuring toilets, cold water demand and hot water demand respectively (Figs 2.11 & 2.12). As stated above, M5 measured rainwater flow to the storage tank from the collection tank in the garden, while M6 measured the mains top-up to the rainwater storage tank. This mains water top-up facility ensured that sufficient water was available for toilet flushing during periods of dry weather. If there was insufficient rainwater in the collection tank, the mains top-up was switched on via the water management system.

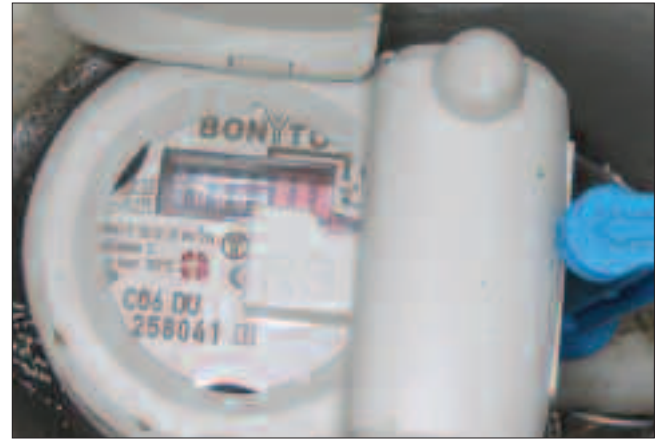
Meters measuring the mains into the house were situated in the path outside (Fig 2.13).

Fig. 2.13 Meter with attached transmitter located externally.

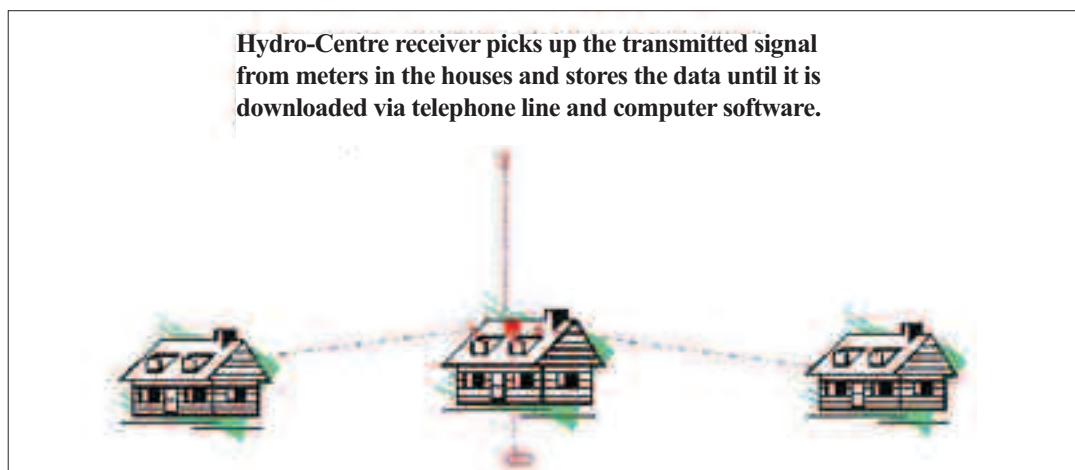
Fig. 2.15 Schematic showing data collection and retrieval.

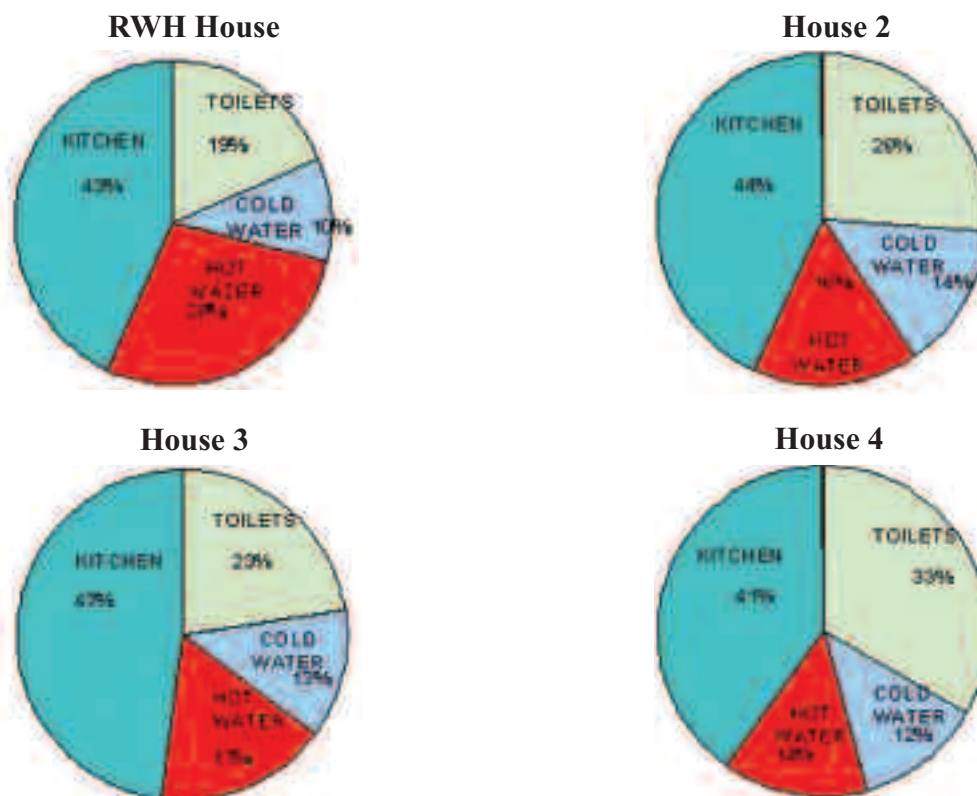
Over the first three months of 2008, captured rainwater exceeded the demand for toilets. Demand for mains water differed between the four households (Table 2.2). The average PCC for the four houses was 111 l per hd-d. The breakdown of water use patterns within households also varied, as shown in Fig. 2.16. Mains water for kitchen use ranged between 41-47%, cold water use between 10-14%, hot water use ranged between 14-28%.

Fig. 2.16 Water use within households.

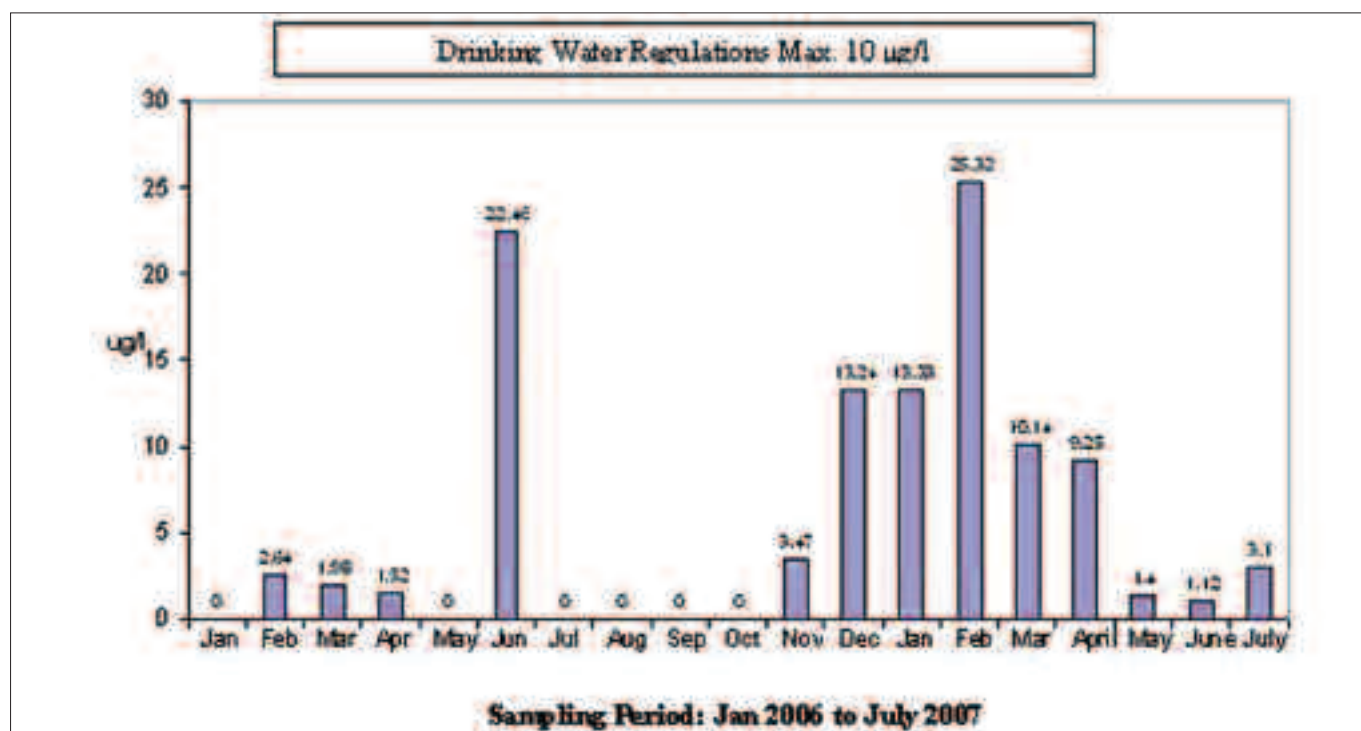
Metals results were all within the limits set out in the Drinking Water Regulations with the exception of Lead. There is no legislation governing the concentration of Calcium in either the Drinking or Bathing Water Regulations. The Iron results showed a mean of 25.66 µg/l, a minimum of 0 and a maximum of 95 µg/l. This is below the 200 µg/l maximum allowed in drinking water. Total Cadmium demonstrated a mean of 0.03 µg/l, a minimum of 0 and a maximum of 0.30 µg/l. Cadmium is not cited in the Bathing Water Regulations, while the parametric value for Drinking Water is 5.0 µg/l. Of all the physicochemical parameters tested, all complied with the Bathing Water Regulations, while two were in breach of Drinking Water Regulations; Lead with a maximum of 25.32 µg/l and pH where a minimum of 6.26 was recorded in one sample.

Fig. 2.17 Harvested Rainwater Quality Results for Lead from Jan 2006 to July 2007. Sampling Period: Jan 2006 to July 2007.

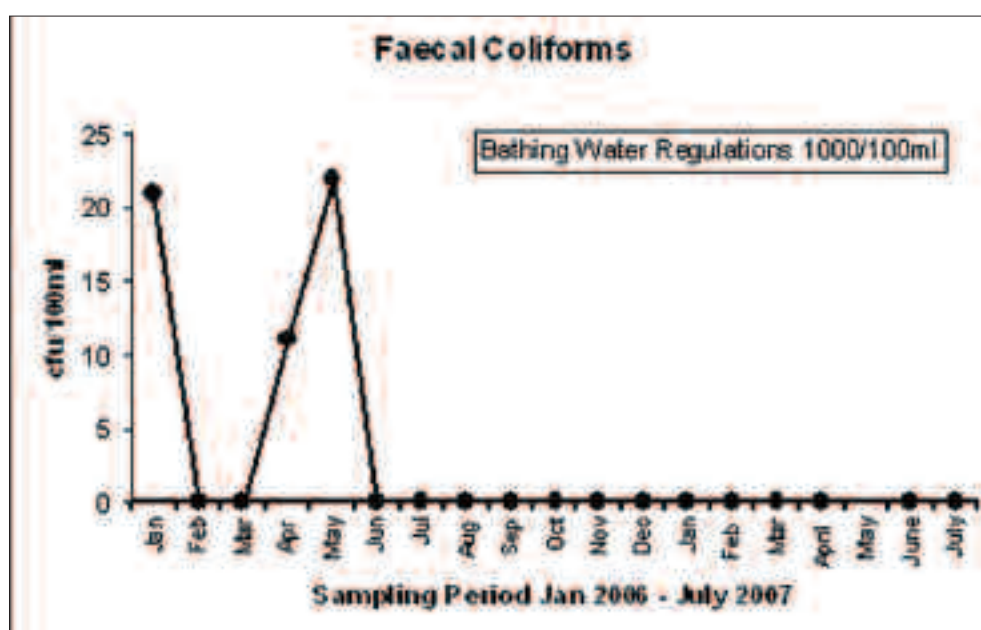
Fig. 2.18 Faecal Coliform results for Harvested Rainwater January 2006 – July 2007.

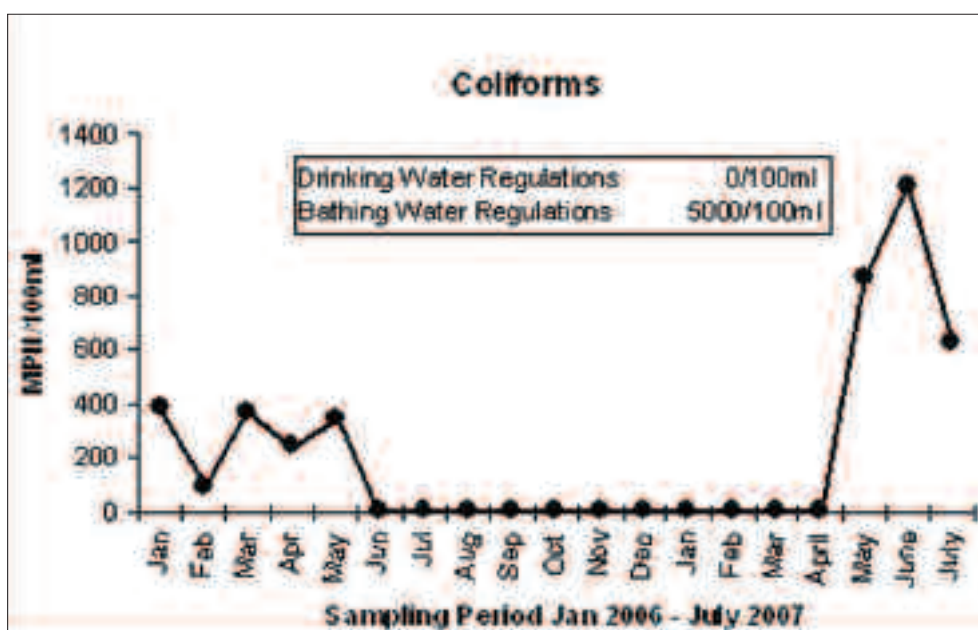
Fig. 2.19 Coliform Results for Harvested Rainwater January 2006 – July 2007.

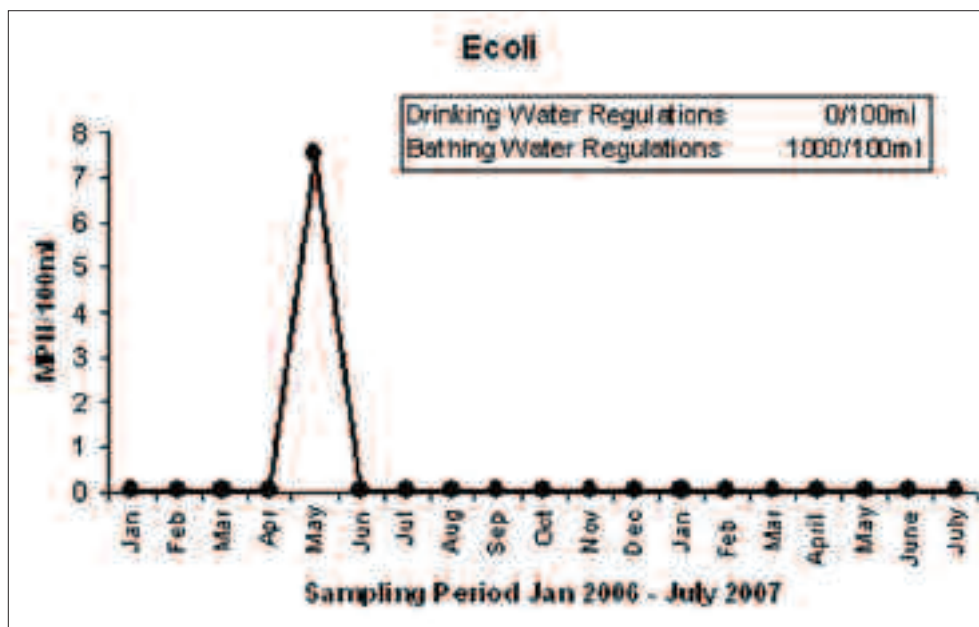
Fig. 2.20 *E.coli* Results for Harvested Rainwater January 2006 – July 2007.

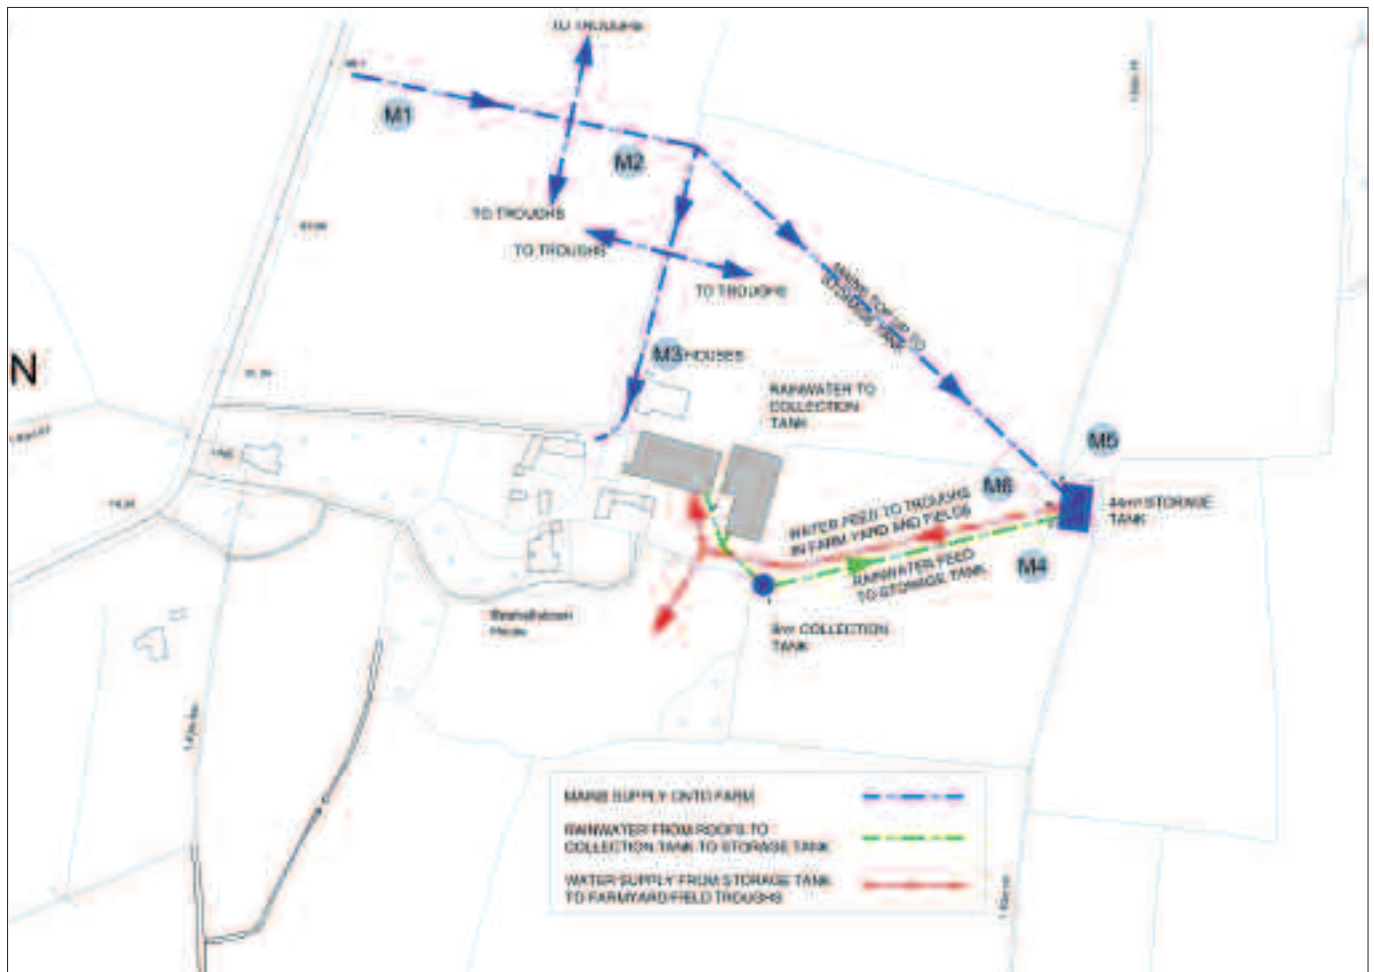
Rainwater from two sheds/barns was drained by gravity to an underground pre-cast 9m³ concrete collection tank. A 200mm high perforated stainless steel plate, overlapped, and of diameter 75mm, was placed in the downpipe gutter, as a filter. The collection tank was fitted with a pump and float switch, and the overflow pipe was connected to an adjacent field drain. The harvested rainwater was pumped via a 25mm rising pipe to two 22m³ pre-cast concrete reservoir tanks located on an adjacent elevated site. A mains top-up connection ensured water supply to the reservoir during periods of low rainfall. The harvested rainwater was distributed, via a 25mm pipe, by gravity to supply drinking troughs for cattle on the farm.

Fig. 3.1 Rainwater supply network.

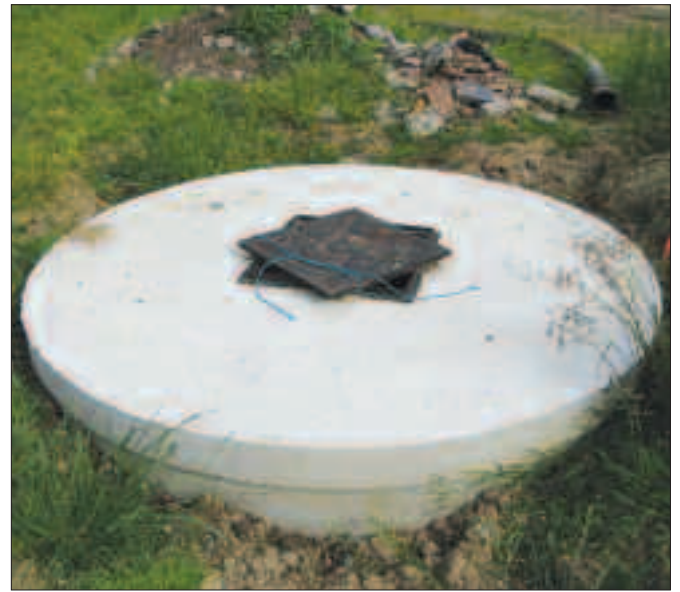
Rainwater drains from the roof catchment to an underground collection tank nearby (Figs. 3.2 & 3.3). From this tank a submersible pump pumps the water up to the storage tanks.

Fig. 3.3 Underground pumping tank.

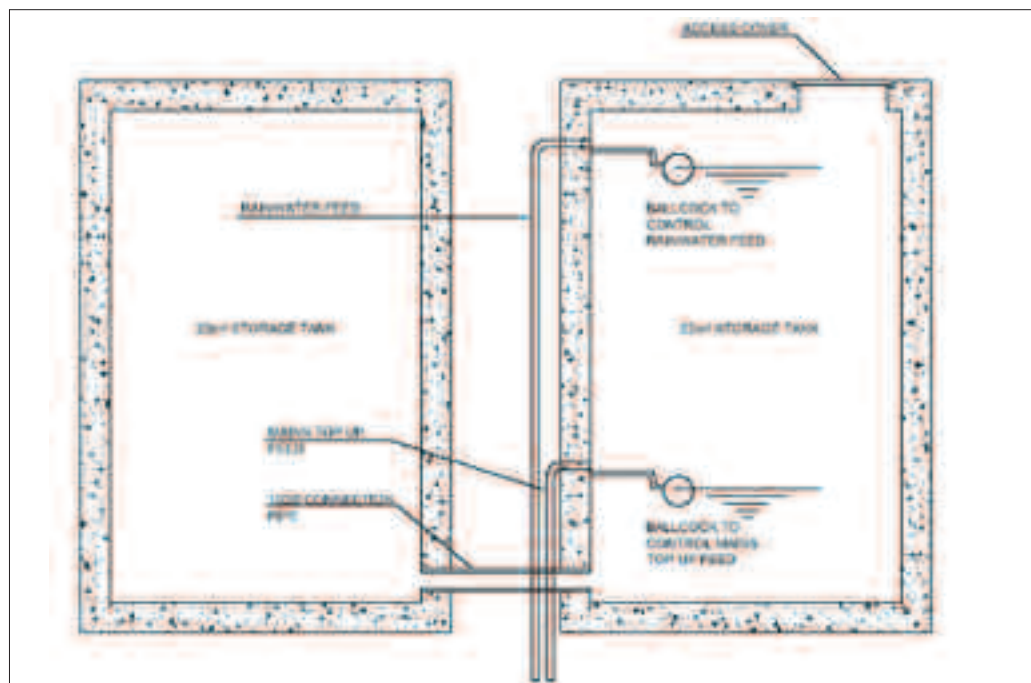
The three options were assessed on cost and technical feasibility and the third option was chosen. The total rainwater storage provided was 40m³, comprising two 22m³ precast concrete tanks interconnected via a 100mm pipe. An overflow facility decreased the total capacity of the storage tank to approximately 40m³. Hardcore foundations were laid for the storage tank, which is situated above ground, at an elevation of approximately 10m above the farm yard.

Fig. 3.4 Rainwater reservoir.

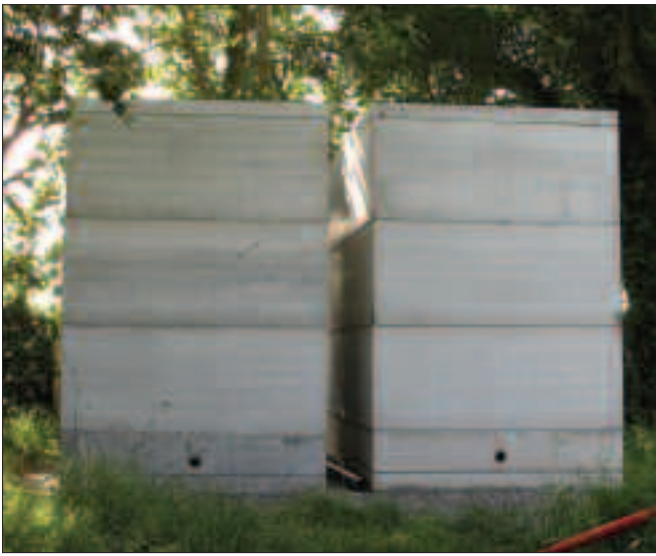
Fig. 3.5 Rainwater storage reservoir.

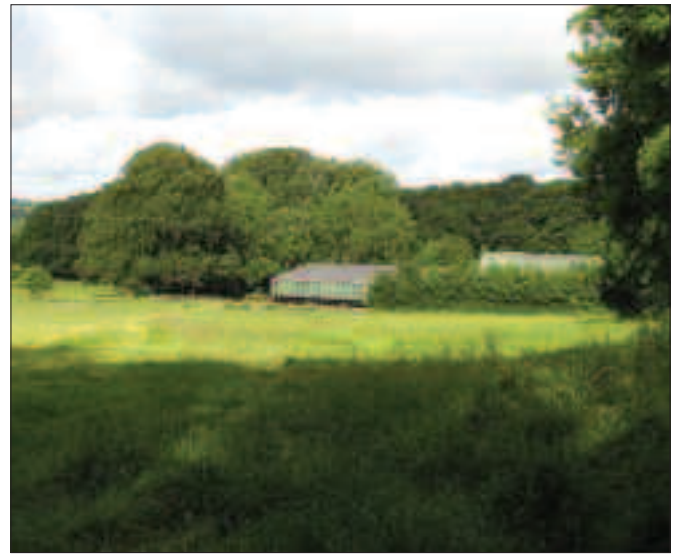
Fig. 3.6 Rainwater supply to drinking troughs by gravity system from storage reservoir.

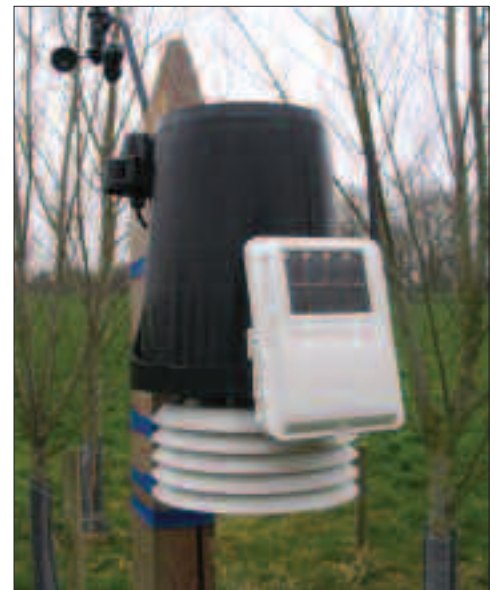
Fig. 3.9 Weather station at Clonalvy.

On the side of one of the tanks were sampling points (Fig. 3.8a & b) from where the quality of the water going into the storage tank and leaving the tanks going to the cattle troughs could be analysed. Both chemical and microbiological tests were performed on the water. As at the Carlow site, weather data was collected (Fig. 3.9). See Appendix for monthly rainfall data.

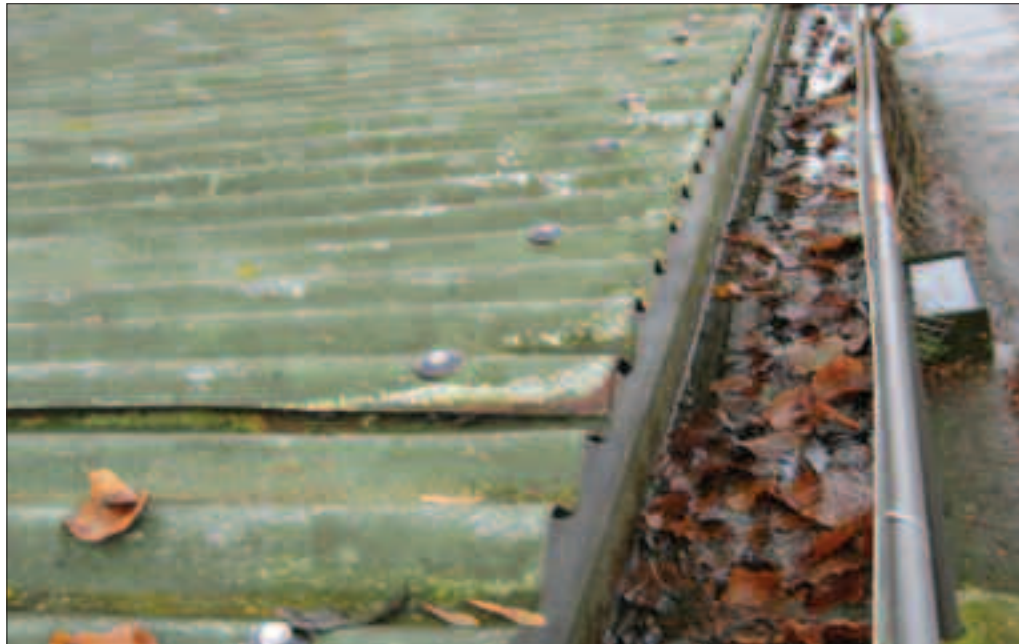
Fig. 3.10 Build up of leaves in gutter leading to failure of custom made filter.

Due to the unsatisfactory performance of elements of the original installation, it was decided to alter components of the Rainwater Harvesting system. A Lindab leafbeater TM and a BRAE TM filter were installed on the three downpipes conducting the rainwater, via the underground pipe work, to the collection tank. The leafbeater was installed prior to the BRAE filter. The design of the leafbeater is such that it allows for the removal of larger solids, while the fine filter on the BRAE traps the finer particles. Installation of the filters required cutting the downpipes. This allowed a reduction in the pressure of the water in the pipe work. The leafbeater is self cleansing while the BRAE filter requires periodic cleaning of a removable mesh. The fine filter on the pump in the collection tank was also replaced. Armstrong Junctions (AJs) covering the underground pipe work in the farmyard were sealed, using a silicon sealant. A data logger system was also installed with flow monitoring to assess water usage.

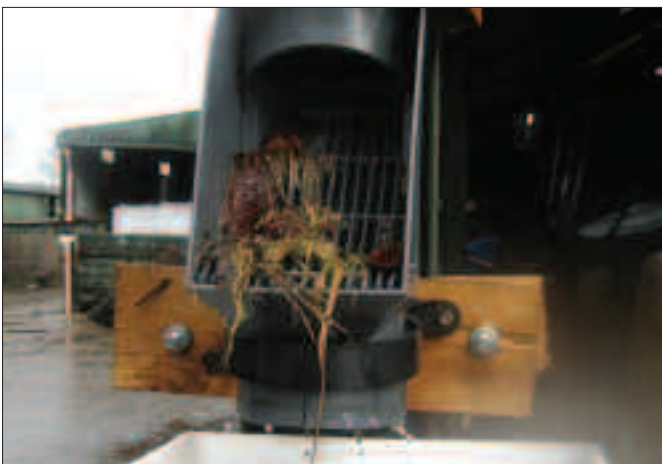
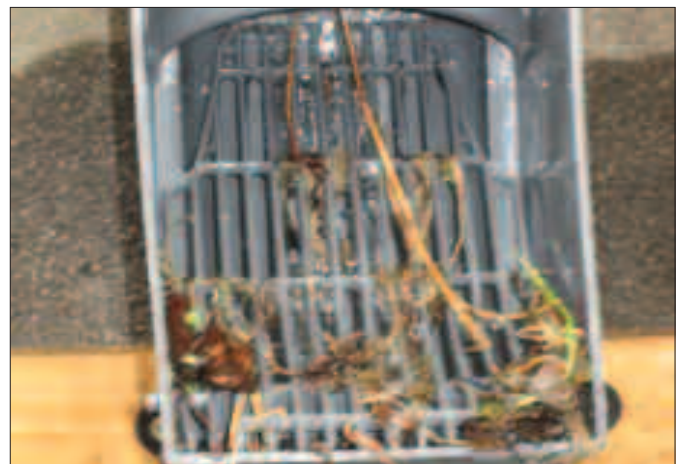
Fig. 3.13 and Fig. 3.14 A Lindab leafbeater TM and a BRAE TM filter installed.

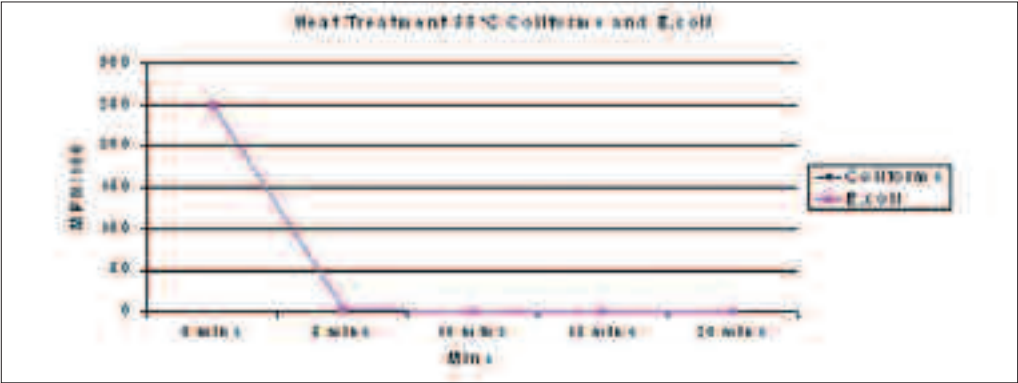
Fig. 4.1 Coliform and *E.coli* results for Heat Treatment Experiments at 55°C.

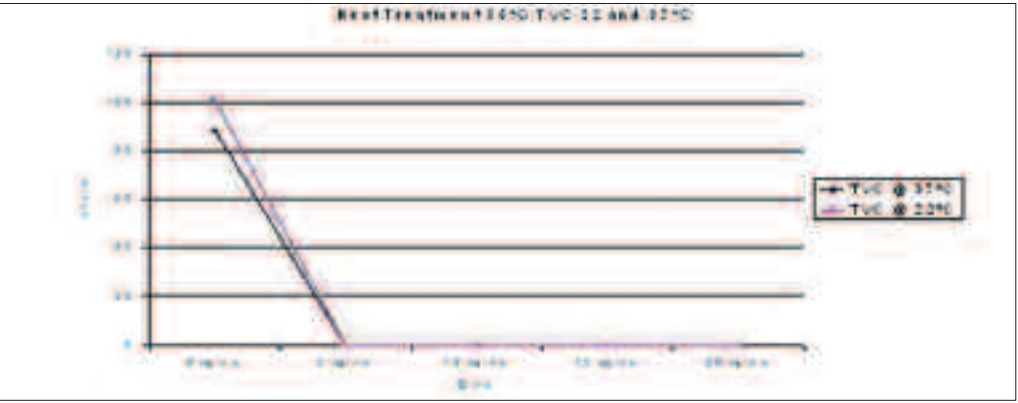
Table 4.1 shows the microbiological results for Coliforms, *E. coli*, Faecal Coliforms, Salmonella, *Pseudomonas aeruginosa* and TVC (at 22°C and 37°C). All water samples incubated at 55°C for 5, 10, 15 and 20 minutes respectively. Values for Coliforms and *E. coli* were highest at Time 0, as would be expected. The sample was taken prior to heat treatment at 55°C. Both the Coliform and *E. coli* results were the same at 248.3 MPN/100ml. After 5 minutes at 55°C, values showed a marked decrease to 2.1 MPN/100ml. At all other times, 10, 15 and 20 minutes respectively, no Coliforms nor *E. coli* were detected in the samples (Fig. 4.1). TVC at 22 and 37°C were also highest at Time 0, 88 cfu/ml at 22°C and 101cfu/ml at 37°C. After 5 minutes no TVC at 22 or 37°C were detected and none at Time 10, 15 or 20 minutes (Fig. 4.2).

Fig. 4.2 TVC @ 22 and 37°C results for Heat Treatment Experiments at 55°C.

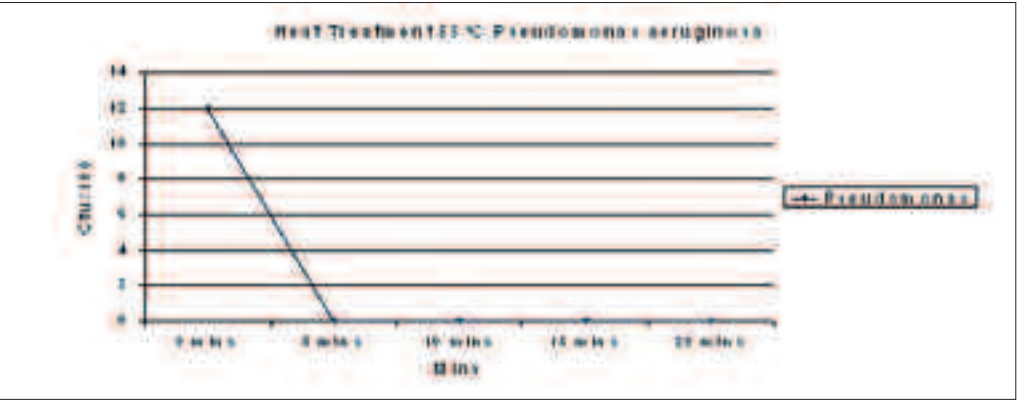
Fig. 4.3 *Pseudomonas aeruginosa* results for Heat Treatment Experiments at 55°C.

Pseudomonas aeruginosa (12 cfu/100ml) was detected at Time 0 minutes. As with TVCs, no *Pseudomonas aeruginosa* was detected at 5, 10, 15 or 20 minutes (Fig.4.3). Faecal Coliforms (36 cfu/100ml) were detected at Time 0 minutes. After incubation, no Faecal Coliforms were detected at 5, 10, 15 or 20 minutes (Fig.4.4).

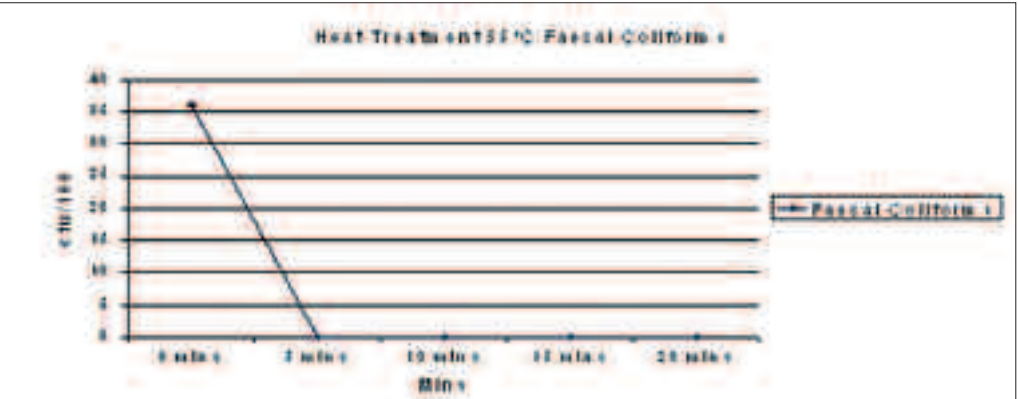
Fig. 4.4 Faecal Coliforms results for Heat Treatment Experiments at 55°C.

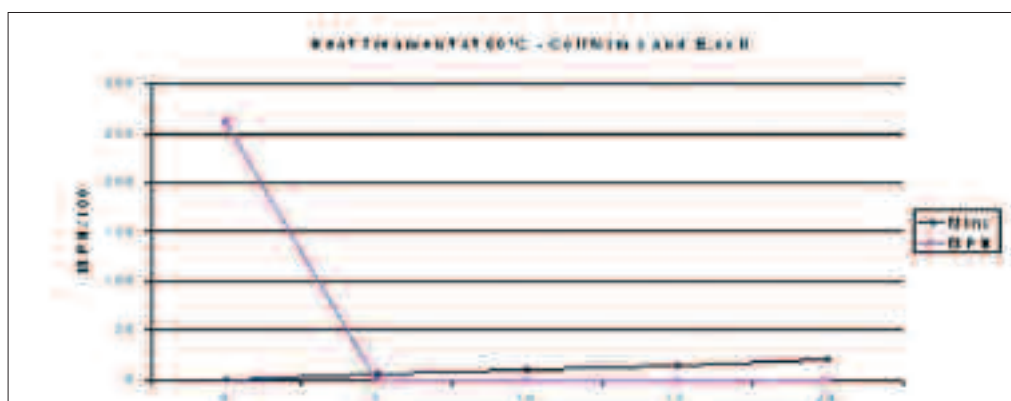
Fig. 4.5 Coliform and *E. coli* results for Heat Treatment Experiments at 60°C.

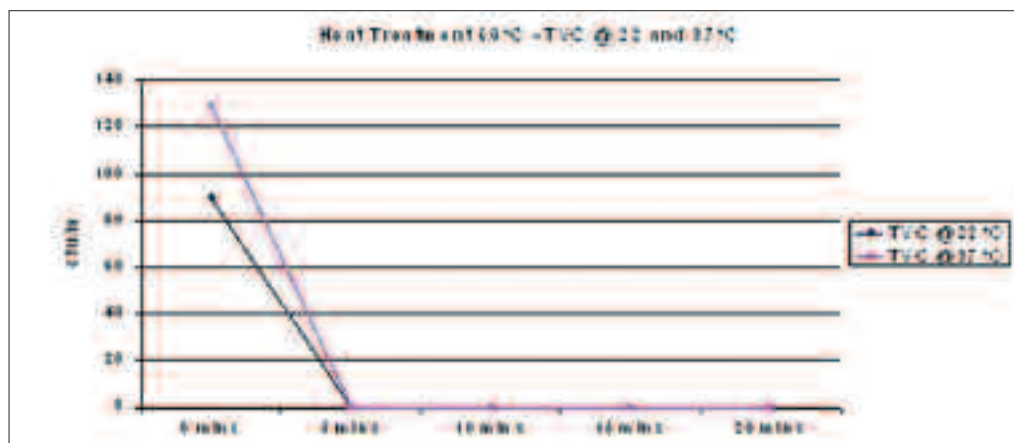
Fig. 4.6 Coliform TVC @ 22 and 37°C results for Heat Treatment Experiments at 60°C.

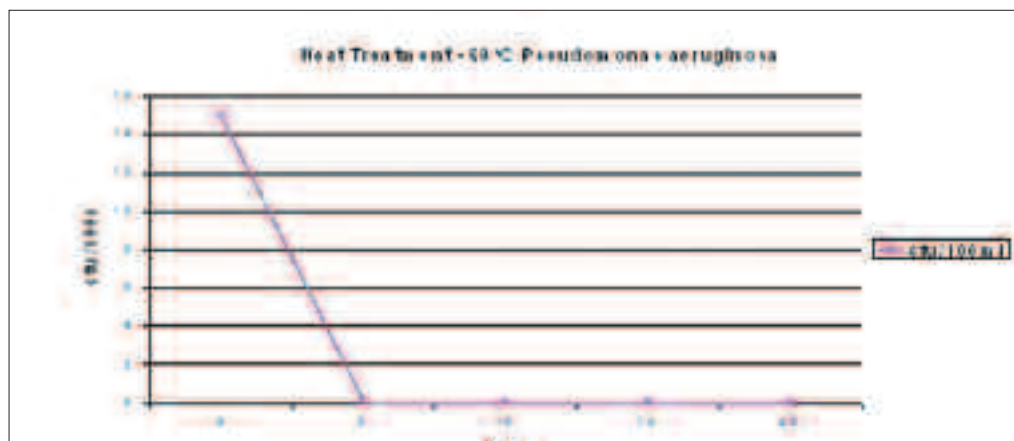
Fig. 4.7 Pseudomonas aeruginosa results for Heat Treatment Experiments at 60°C.

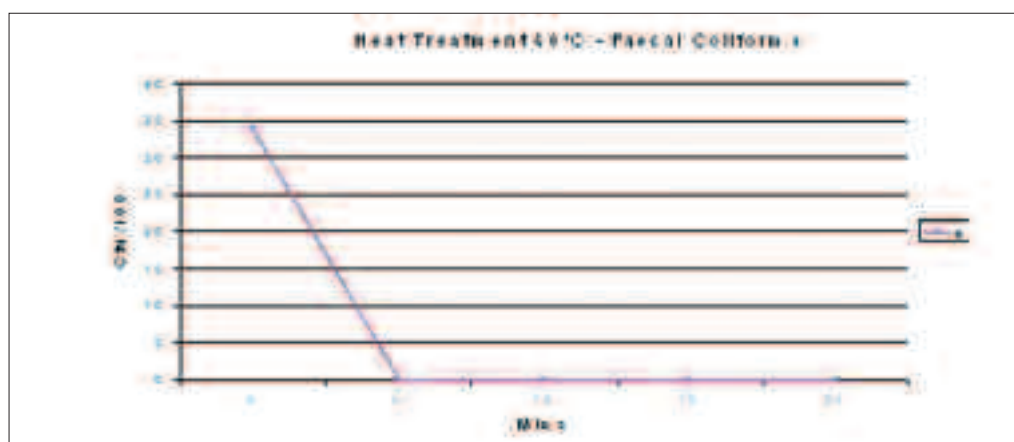
Fig. 4.8 Faecal Coliform results for Heat Treatment Experiments at 60°C.

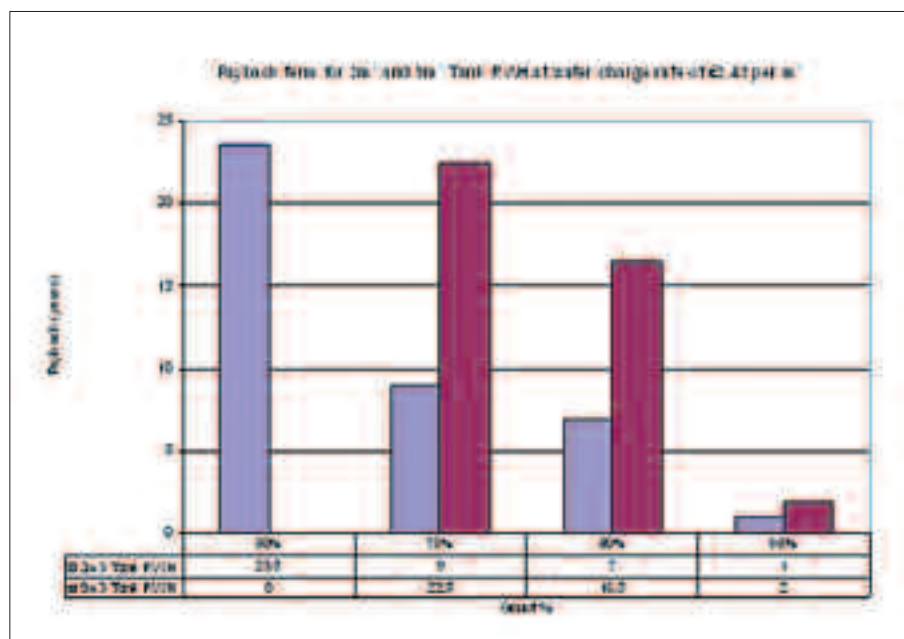
Fig. 5.1 Payback period for 2m³ and 9m³ RWH system with water charges at €2.43 per m³.

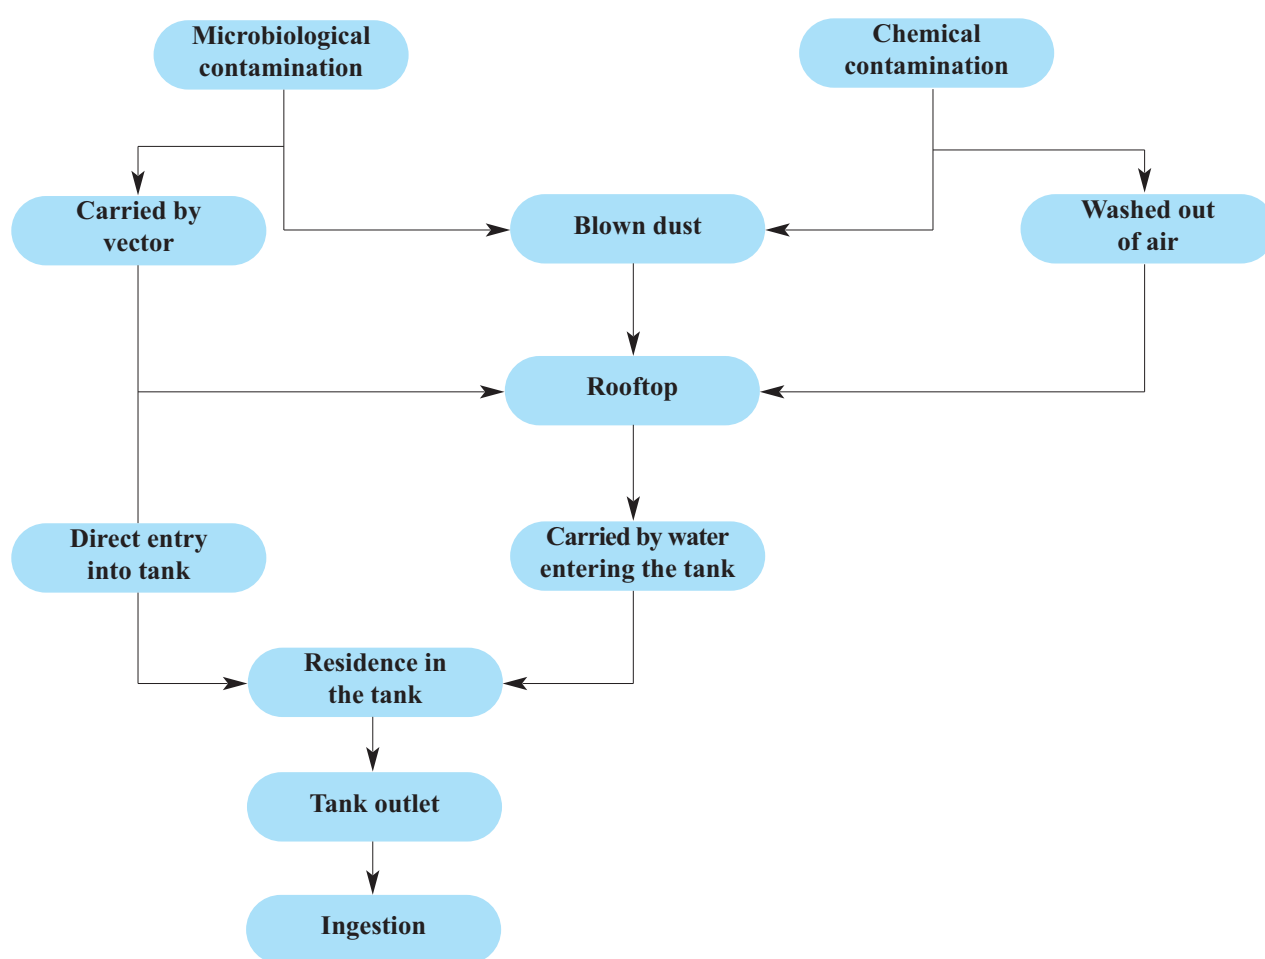
When considering the water quality of a rainwater harvesting system, it is useful to observe the complex path a contaminant must follow in order to enter a human being. The usual paths are shown in Figure 1.

Fig 1 Contamination pathways for Rainwater Harvesting (Thomas, 2007).

Fig 1 illustrates the possible contaminant pathway routes within a typical rainwater harvesting system. As the water passes through the various stages in the system it is exposed to processes that simultaneously reduce/eliminate the microbiological load. Fig 2 illustrates these treatment processes. A domestic rainwater catchment contains a number of components. The roof top provides the entry point for the majority of contaminants, although parallel processes simultaneously reduce the microbiological load through UV, heat, and desiccation. Within the tank, it has been shown that biofilms actively remove heavy metals and organics from the water column, while sedimentation and surface flocculation also remove contaminants from the available water supply. Tank water must pass through a pump and possibly through a hot water system before human contact, which impose sudden stresses on bacteria, disrupting cell structure and integrity.

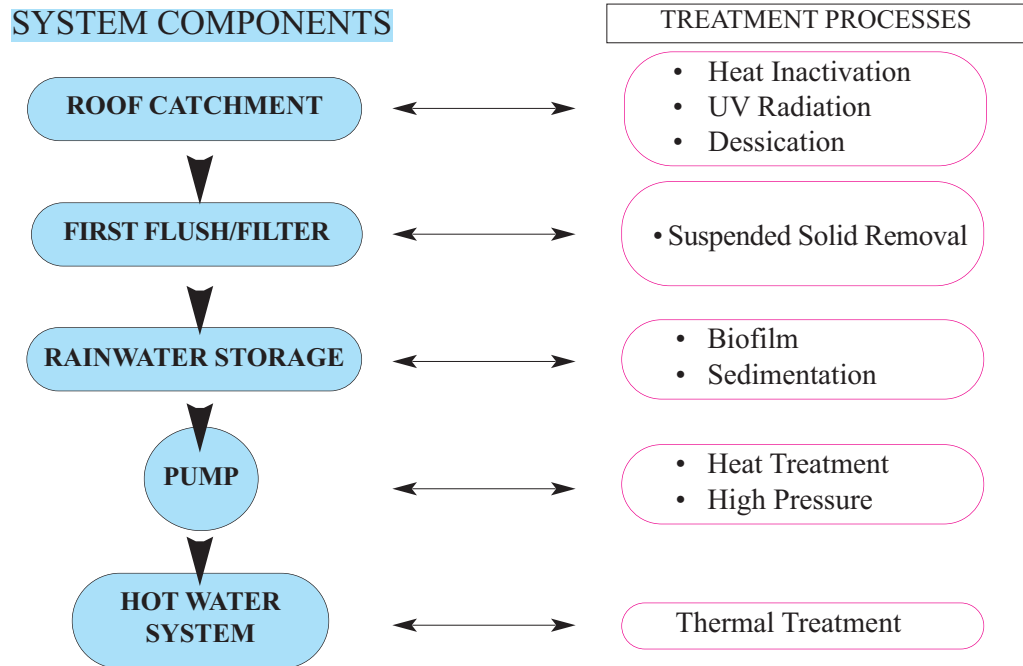
Fig 2 Treatment processes within a rainwater harvesting system.

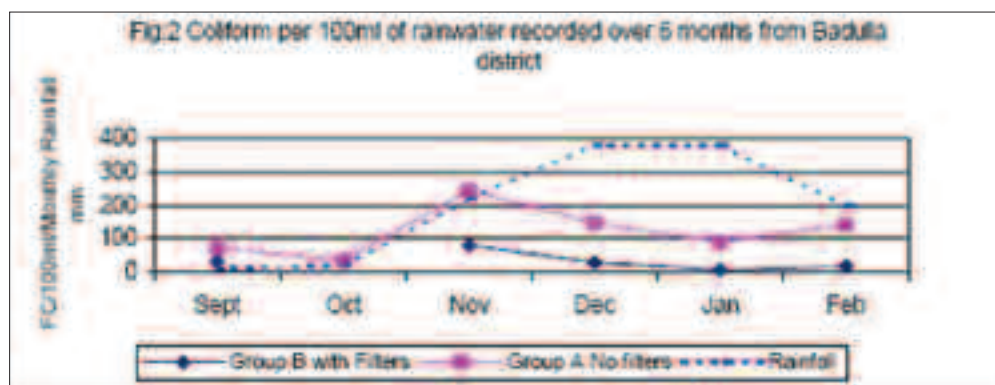
Fig. 3 illustrates the results from a study of rainwater harvesting systems in Sri Lanka. Concentrations of coliforms per 100ml of rainwater varied according to seasonal factors, the greatest deterioration occurring during rainfall that followed a dry spell. As the volume and intensity of rain increased, however, the level of coliforms decreased once more. This demonstrates that wash-out impacts considerably on the harvested rainwater quality.

Fig 3 Rainwater Harvesting Water Quality, Sri Lanka (Ariyananda T. N. 1999).

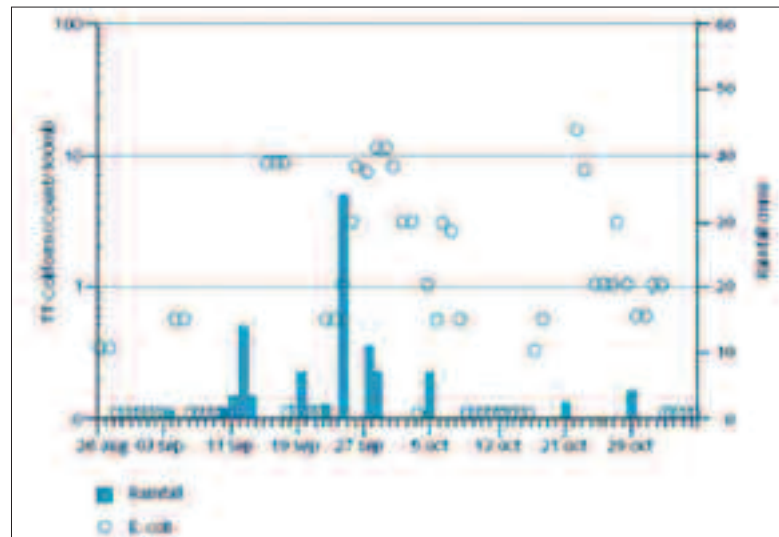
Further evidence of the seasonal effects of harvested rainwater quality can be deduced from a study by IRC (Thomas, 2007), the results of which are presented in Fig. 4. Levels of indicator bacteria rise after rain and then fall over time until the next rain. Reductions of 90% of Total Coliforms have been noted after about 3 days, though this varies somewhat with local conditions.

Fig 4 Episodes of rainfall and average of indicator bacteria taken from tanks in one location.

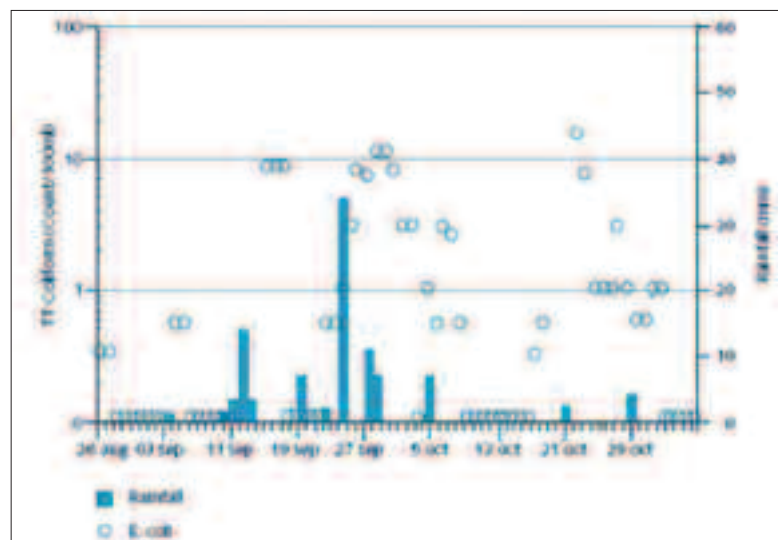
Fig 5 *E. coli* recorded in samples taken from a rainwater tank in Addis Ababa (T. Ariyananda, 2003).
