Rainwater Harvesting Pilot Project

This study and report were undertaken under the auspices of the National Rural Water Monitoring Committee by a project team from the School of Civil and Structural Engineering at Dublin Institute of Technology. The project team was led by Dr Seán Ó hÓgáin and Liam McCartan and included Anna Reid, Niamh McIntyre and Jenny Pender.

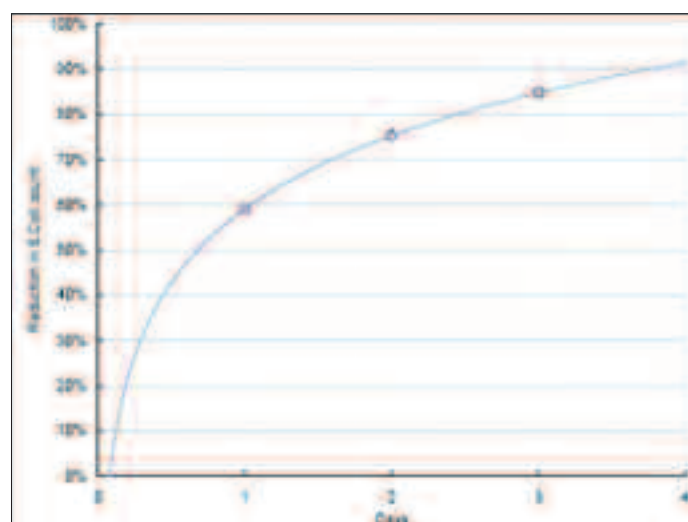
Further harvested rainwater quality studies conducted in countries with different systems, climate and locations, record zero *E. coli* in 35-55% of the samples collected, thus complying with WHO recommended standards. Many other samples recorded less than 100 *E. coli*/100 ml of rainwater, falling into the “intermediate risk” according to the WHO standard. This is far below the *E. coli* levels recorded from other rural sources, such as wells. Studies from a project in Addis Ababa, Ethiopia have shown that *E. coli* levels in rainwater tanks are influenced by rainfall (Figure 5). High levels are recorded immediately after rain. However, bacterial levels decrease within 4-7 days, if no fresh contamination occurs (Figure 6).

Fig 6 Bacterial die-off recorded from rainwater tanks (T. Ariyananda, 2003).

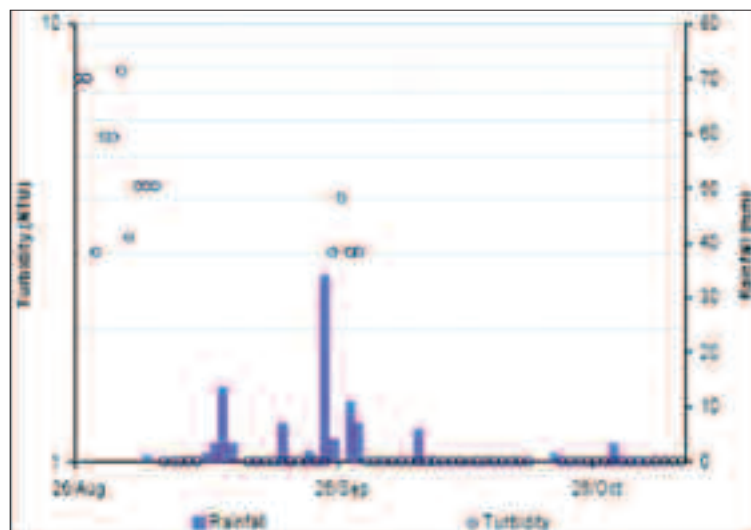
The chemical and physical quality of rainwater may not directly cause a health risk but it can influence water disinfection methods and promote bacterial growth. However, the physical and chemical quality of drinking water directly affects its acceptability to consumers. High levels of turbidity can protect micro-organisms from the effect of disinfection, stimulate the growth of bacteria and give rise to significant chlorine demand. Disinfection requires that turbidity is less than 5 NTU; ideally, median turbidity should be below 1 NTU. Turbidity recorded from most rural locations are below 5 NTU. In urban locations turbidity can be high due to local pollution and dust settling on the roofs. Turbidity in tanks correlates with rainfall pattern, high turbidity being recorded soon after rain (Figure 7).

Fig 7 Turbidity levels in rainwater tanks in relation to rainfall amounts.
